RESULTS OF 2010 ARCHAEOLOGICAL INVESTIGATION  
LATHROP HOUSE BASEMENT  
PAUL REVERE MEMORIAL ASSOCIATION  
BOSTON, MASSACHUSETTS

Submitted to:  
Paul Revere Memorial Association  
Boston, Massachusetts

Prepared by  
Kathleen Wheeler, Ph. D.,  
and  
Jessica Kramer

IAC Report # 1011  
December 17, 2010

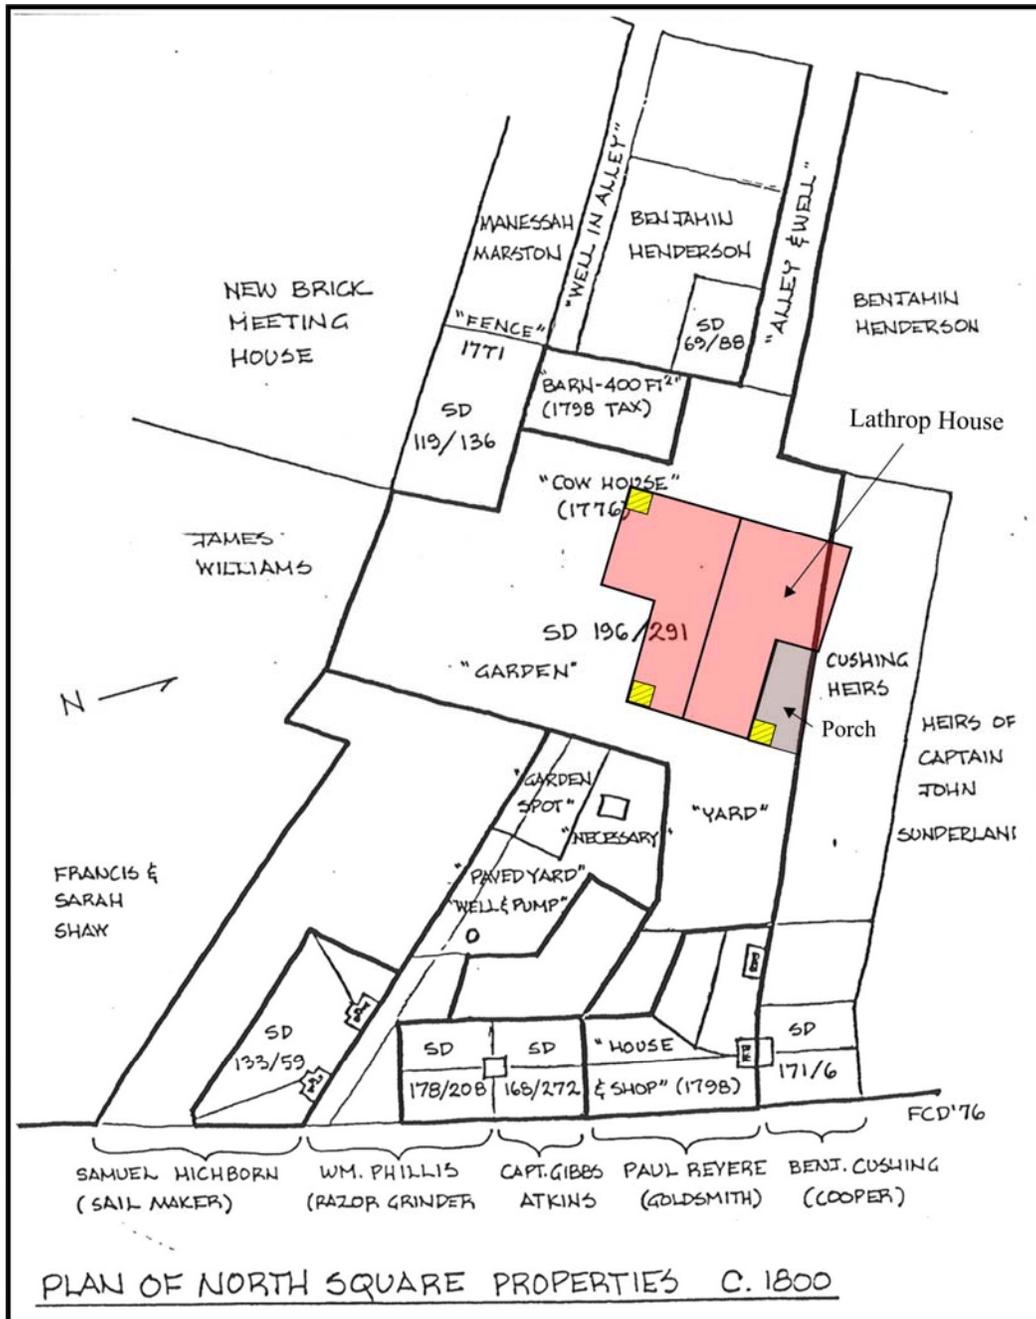
Figure 19. Approximate location of Lathrop House and 2010 excavation units compared to 1800.

In 1800, the south EU is still in the vicinity of the 1776 “cow house,” while the east and north excavation units fall within the large area designated as “garden.” Beginning in 1741, when the widow Howard sold the property, occupation in the second half of the 1700s was taken up with a variety of mariners and tradesmen, of whom one is the silversmith, Paul Revere. Paul Revere acquired the property at 19 North Square in 1770, he rented out the house between 1780 and 1790 or so, and then resided in the house until 1800. While the social status of the various occupants would never achieve the height of the merchant Howard, these occupants (Knox, Revere, Defrance, and Dunkerly) are likely to have had sufficient personal wealth to purchase the English white salt-glazed stoneware, buff-colored-coarse earthenware, tin-enameled wares found in the south and east EUs.

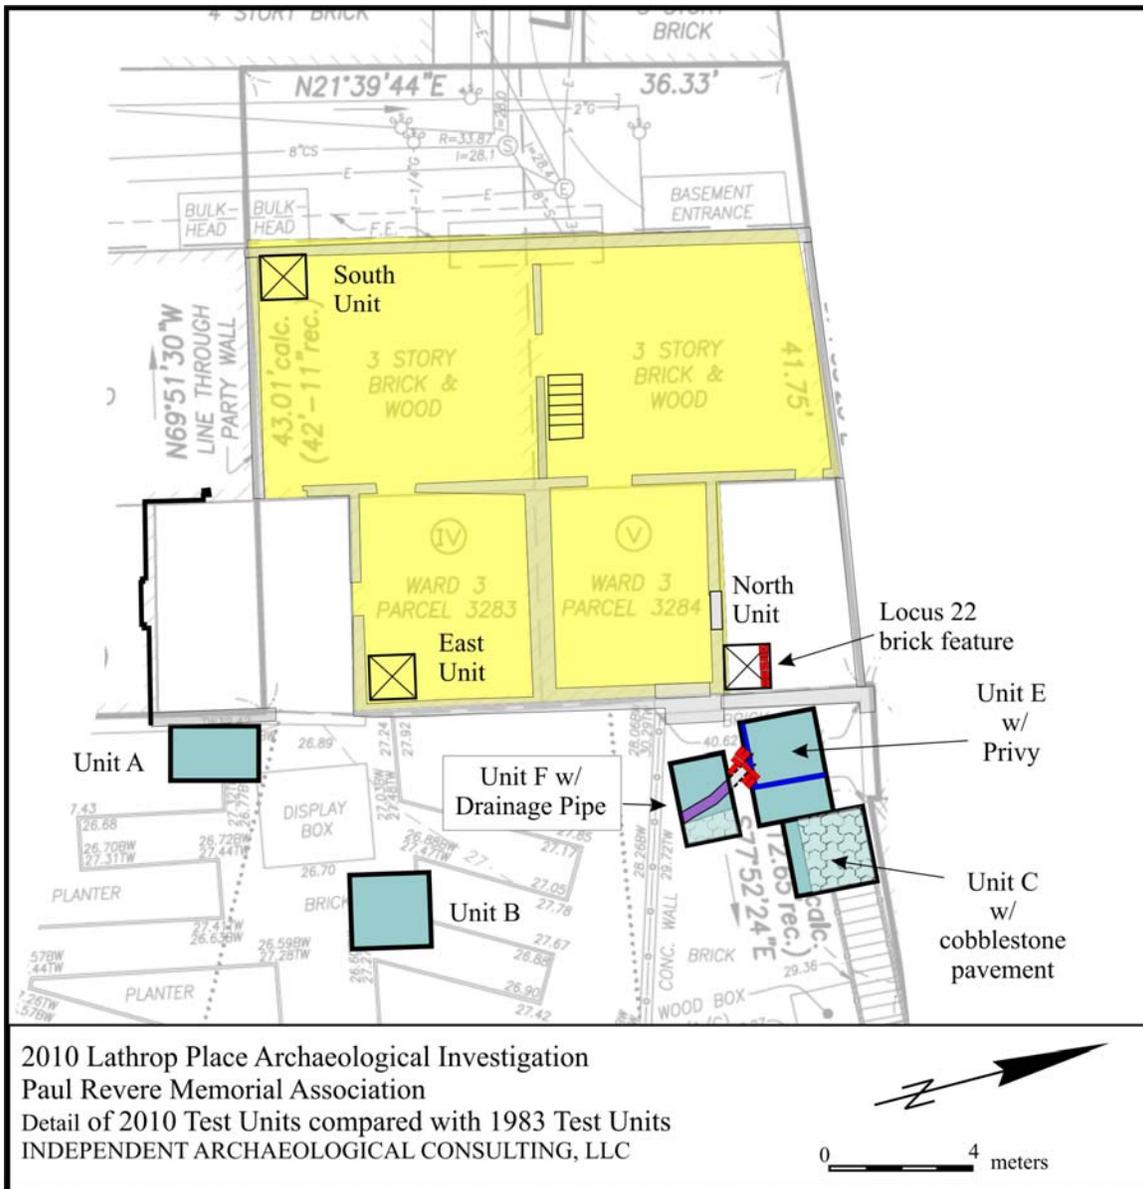
Figure 21. View of IAC excavation units compared to 1983 BU units. Note the proximity of drainage feature, cobblestone pavement, and 19<sup>th</sup>-century privy encountered by BU immediately to the exterior of the North Unit beneath the wooden deck of Lathrop House.

In the north EU (N208.3 E208.1), IAC encountered a brick feature. It appears to be similar to the brick feature uncovered by Boston University in their 1983 investigation, but it is aligned perpendicular to the brick feature (L. 22) uncovered by IAC in 2010 (Figure 21). We recommend further archaeological investigation beneath the porch to discern how Locus 22 is related – if at all – to the brick-and-stone drainage feature of BU’s Unit F.

Boston University conducted analysis of the privy contents and found two distinct deposits. The upper layers contained artifacts that put the date of the fill sometime after the 1890s. The lower privy layers, however, appeared to date to the 1870s. Given the dates of these deposits, it is likely that the privy in Unit E was built up against the exterior wall of the Lathrop House. However, it is possible that the privy *pre-dated* the construction of the Lathrop House with a portion of it continuing beneath the wooden deck of the Lathrop House. BU found many early artifacts at relatively shallow depths beneath the 1983 ground surface, and these yard deposits probably extend beneath the deck. Archaeologists may find the western continuation of a cobblestone pavement exposed in 1983.

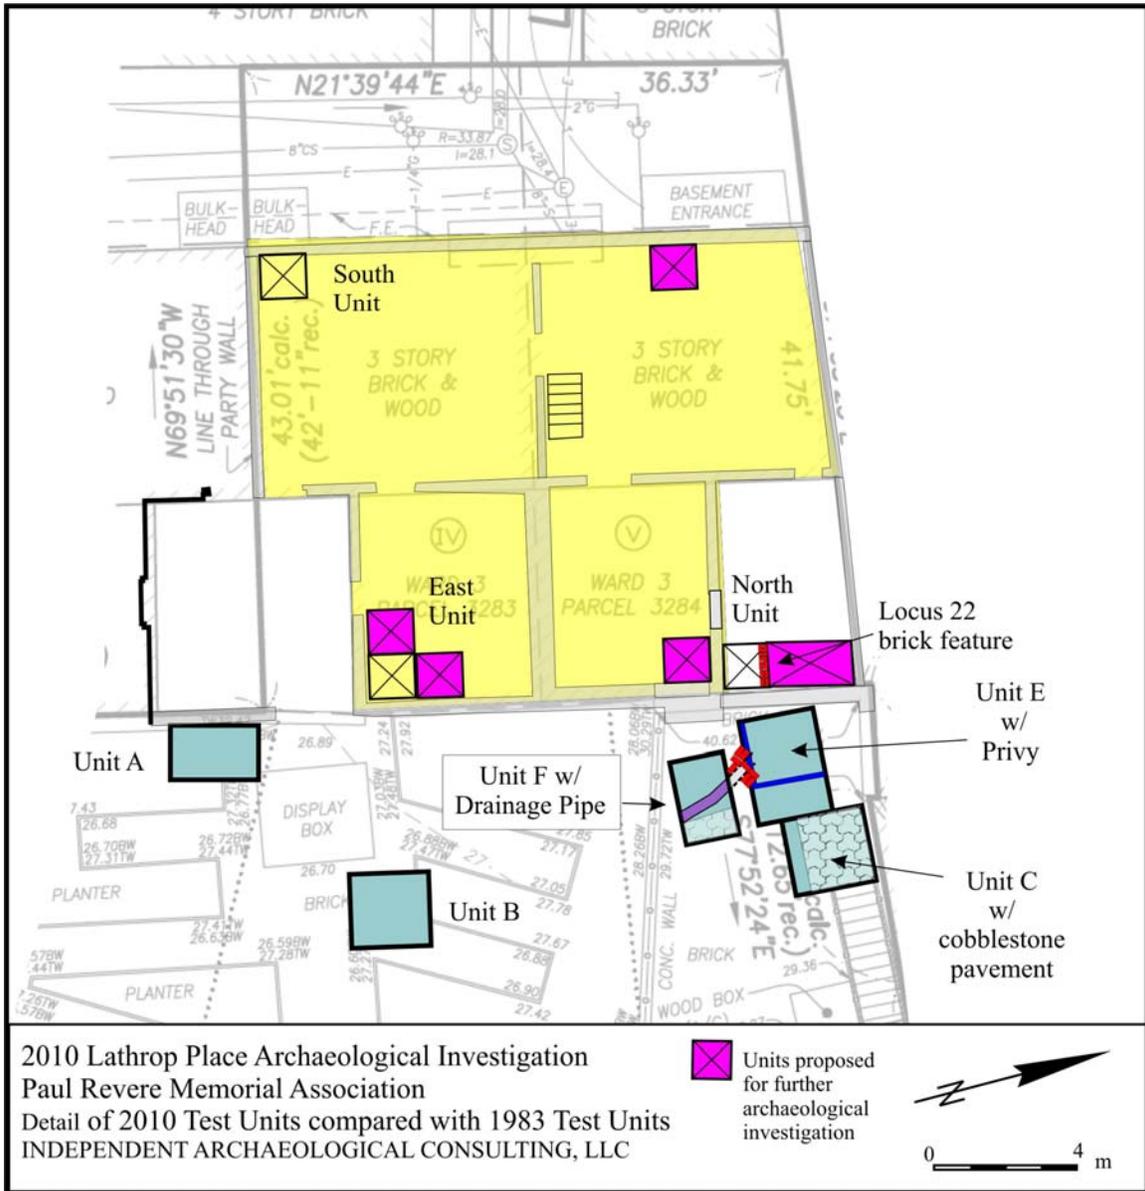
Figure 22. Proposed additional archaeological investigation for the Lathrop House at the Paul Revere Memorial Association.

It is difficult to make generalizations about other parts of the basement, where no sampling took place. Minimally, we recommend testing in two additional areas, as shown in Figure 22 to see confirm whether deposits are disturbed or intact.

- In the area beneath the deck at the northeast end of Lathrop House, we propose additional excavation to expose more of Locus 22 in its length and depth. We recommend also that the excavation area be extended across the width of the deck, as shown in Figure 22.

- In the untested part of the basement, we recommend the hand excavation of two (2) excavation units, each measuring 1.3 m<sup>2</sup> (4 ft<sup>2</sup>) to confirm the nature of deposits beneath the concrete floor. These units should be excavated the northwest and northeast rooms, as depicted in Figure 22.
